# CORNER RECORD

Agency Index CS2021-0008

City of El Macero, Davis County of Yolo, CaliforniaBrief Legal Description Lot 61, El Macero Unit No. 1, Book 5 of Maps, at Pages 89-92

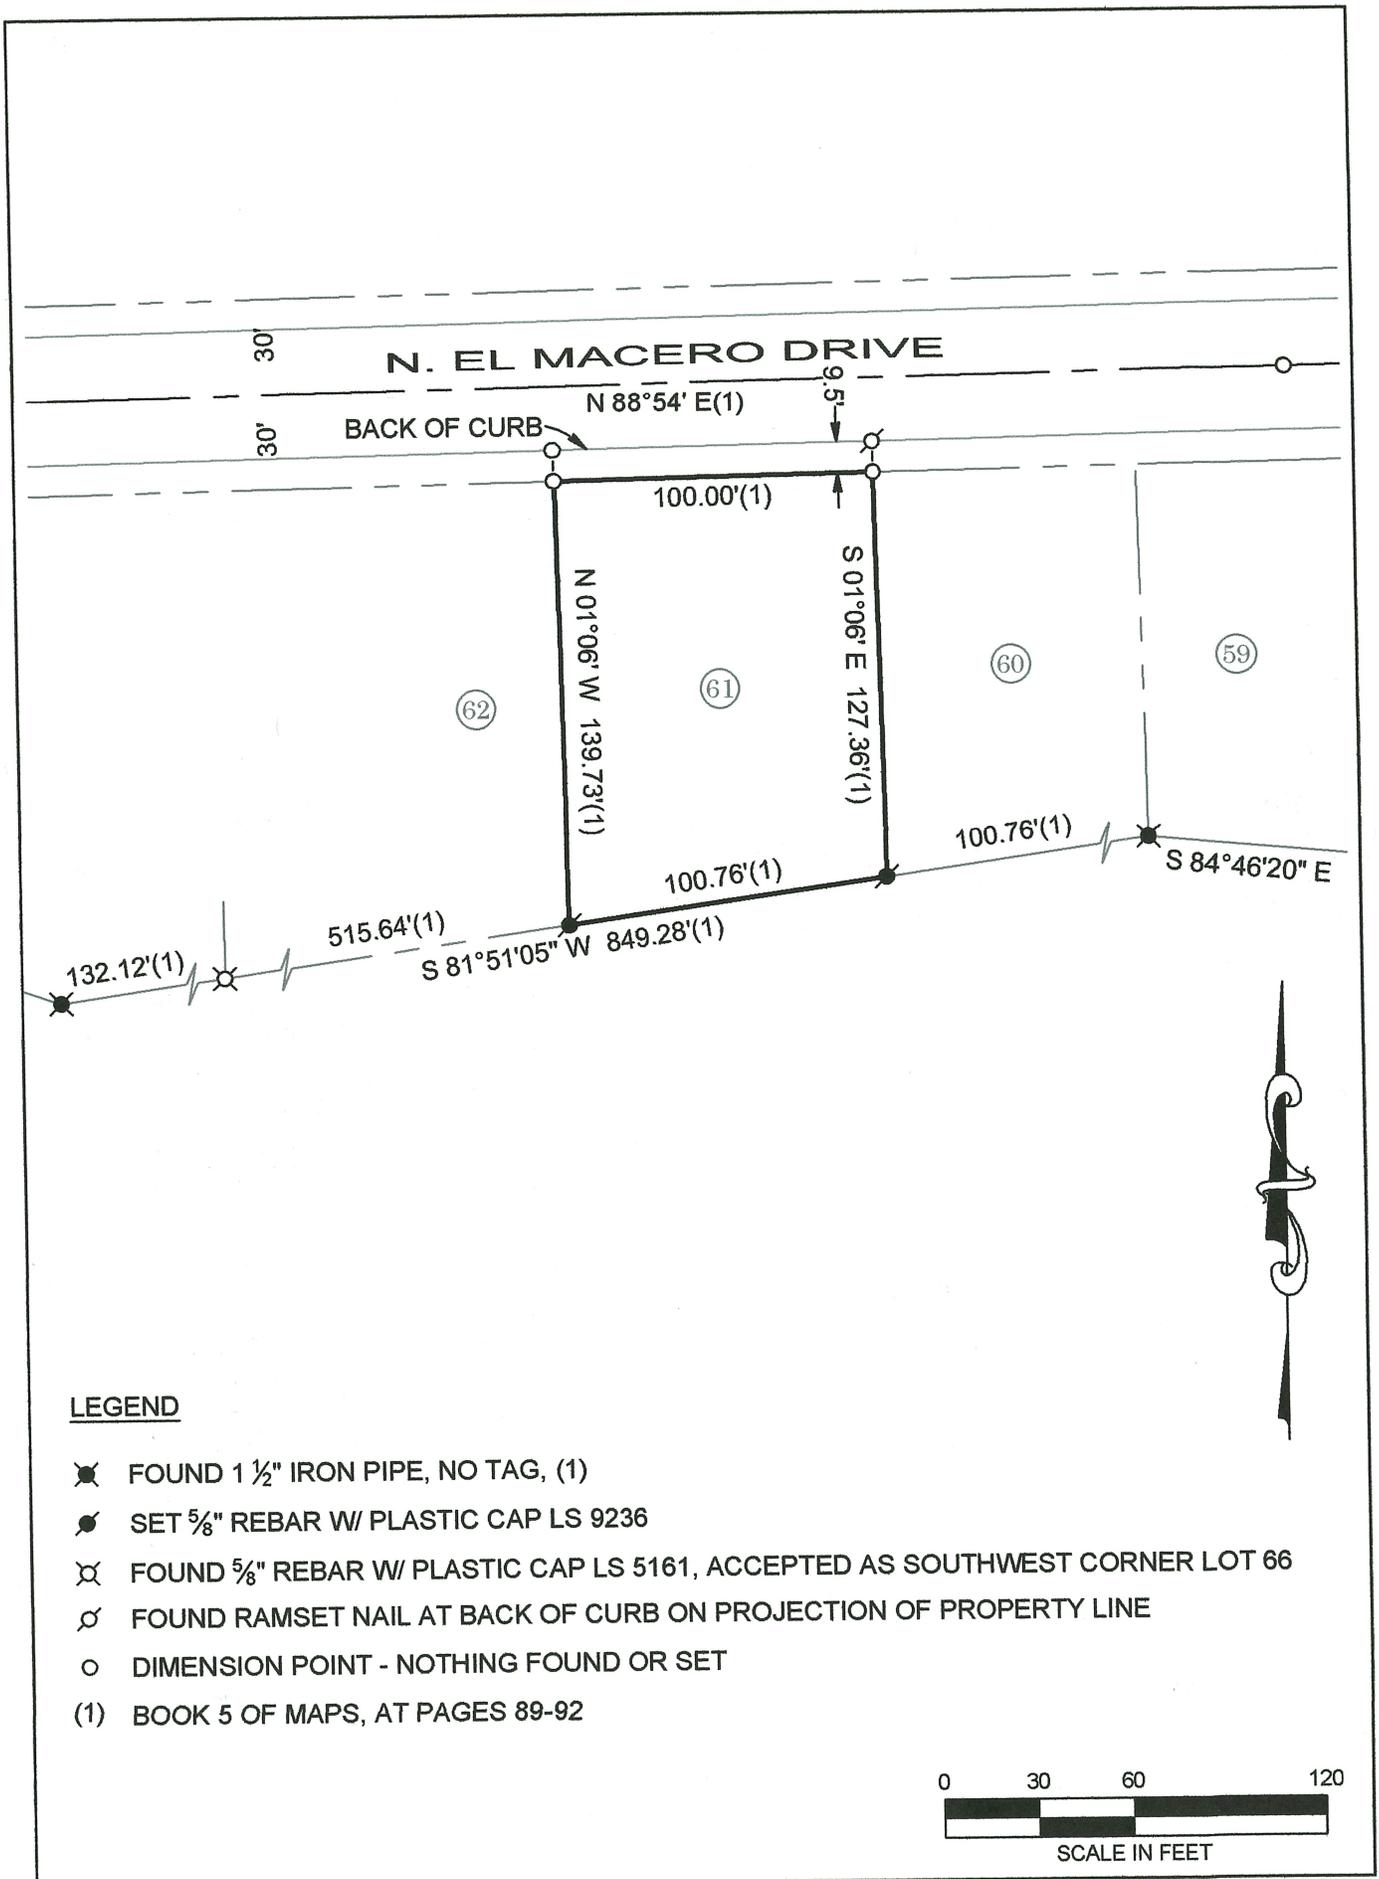
See sheet #2 for description(s):

Original 1 1/2" Iron Pipes per Book 5 of Maps, at Pages 89-92 were found at the rear angle points of said Map. Set 5/8" rebar with Plastic Cap LS 9236 at Southwest and Southeast corners of Lot 61.

Ramset nail was found in the curb on the projection of the easterly lot line of Lot 61. Like nails (or evidence of a missing nail) were found on both sides of N. El Macero Dr. on lot line projections.
